Conceptual Site Model Report

**Axil Belko
Kingsville, MD**

MDE Case Number: 1991-0916-BA4

April 14, 2010

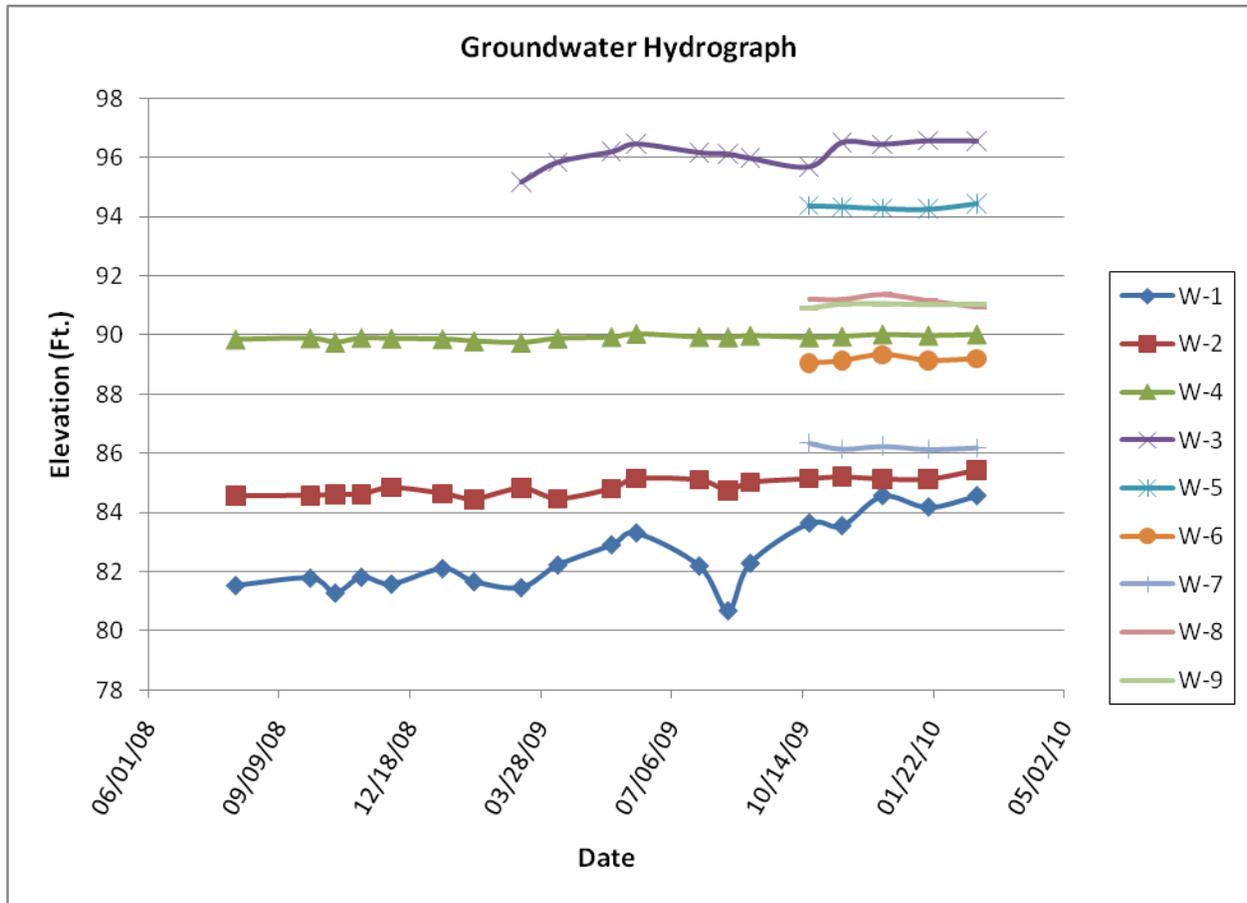
Groundwater Elevations for Corresponding Monitoring Wells

Depth to water measurements and calculated groundwater elevations for the monitoring wells are summarized in the attached **Table 1**. The apparent groundwater flow direction is toward the east with an average groundwater hydraulic gradient of 0.138 ft/ft. A total of nineteen (19) groundwater gauging events have been completed since August 2008 with wells 5-9 starting in October 2009 (5 events). The corresponding average groundwater elevation contour map (August 2008 – February 2010) is attached as **Figure 4** and a graph of the data is presented below.

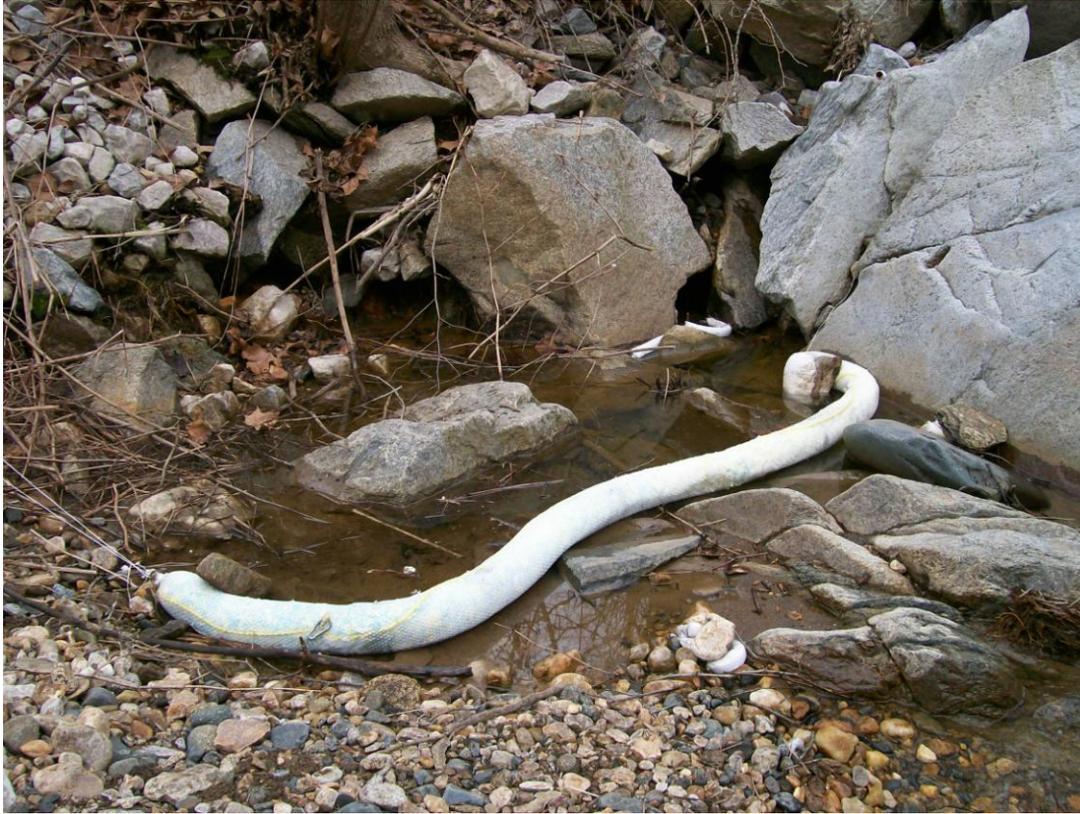
The most recent occurrence of LNAPL in a seep was at Outfall 3 and was observed February 28, 2010. During this time, large volumes of water were being flushed through the subsurface as a result of melting snow and rain. Outfall 3, typically observed as a natural seep, was flowing steadily in many locations. Oil absorbent booms (**pictured below**) were immediately installed in the discharge “pool” for Outfall 3. It should be noted that “Outfall 3” is in line with MW-1 and the source area indicating a preferential flow path for the perched groundwater.

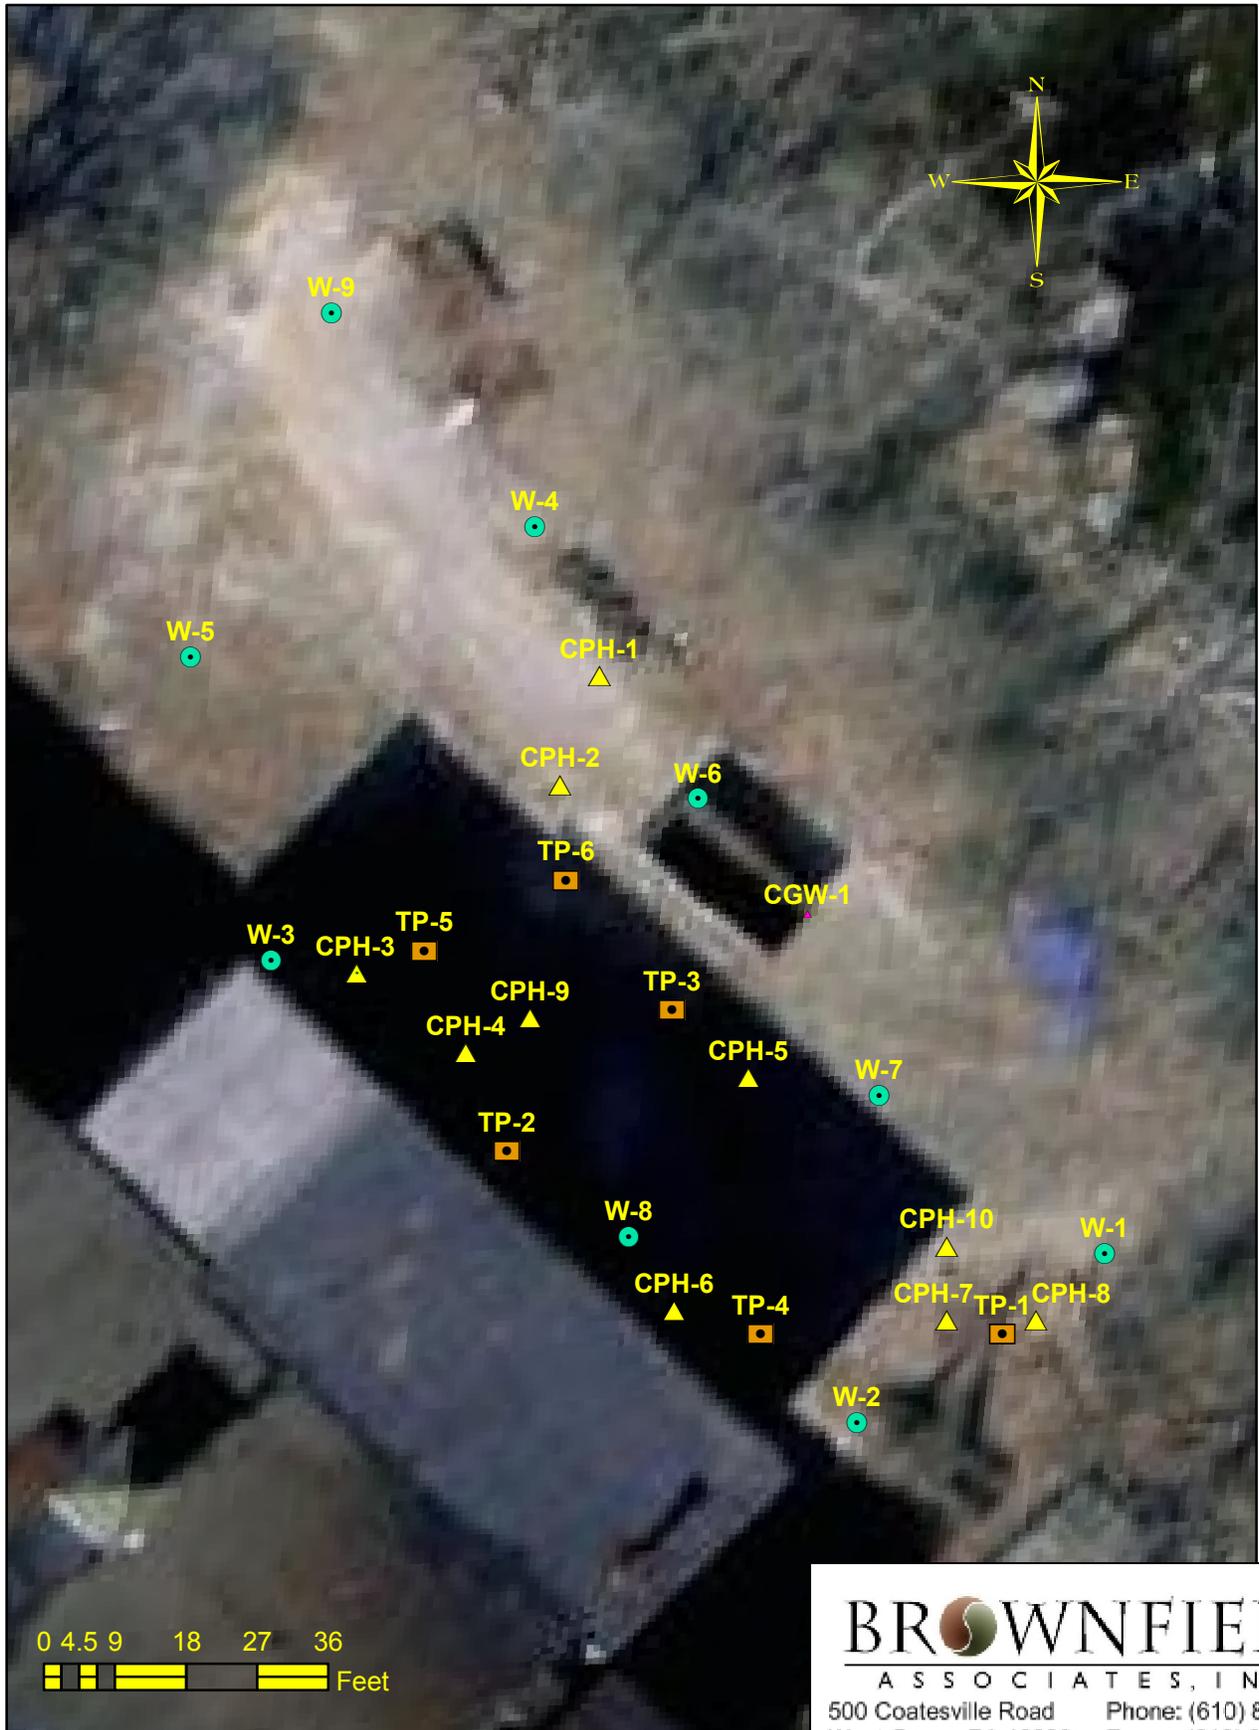
FIGURE 2
 AREA "C" Location MAP
 AXIL BELKO FACILITY
 KINGSVILLE, MD

While it was in operation, the facility's potable water was supplied primarily by a groundwater well located in the western portion of the property. Another potable well was located on the eastern side of the office building but was not being used for potable water when the facility closed due to bacteria concerns. The focus of this CSM Report is in the area labeled "Area C" in the Phase II report by Tristate (Figure 2).

A Phase II was performed to assess the extent and magnitude of potential impacts in the areas identified as potentially recognized environmental conditions in the Phase I report. The Phase II included soil and ground water sampling in up to ten (10) designated areas (A-J). Area C is the focus of this CSM report; the eastern portion of the property (Figure 2).

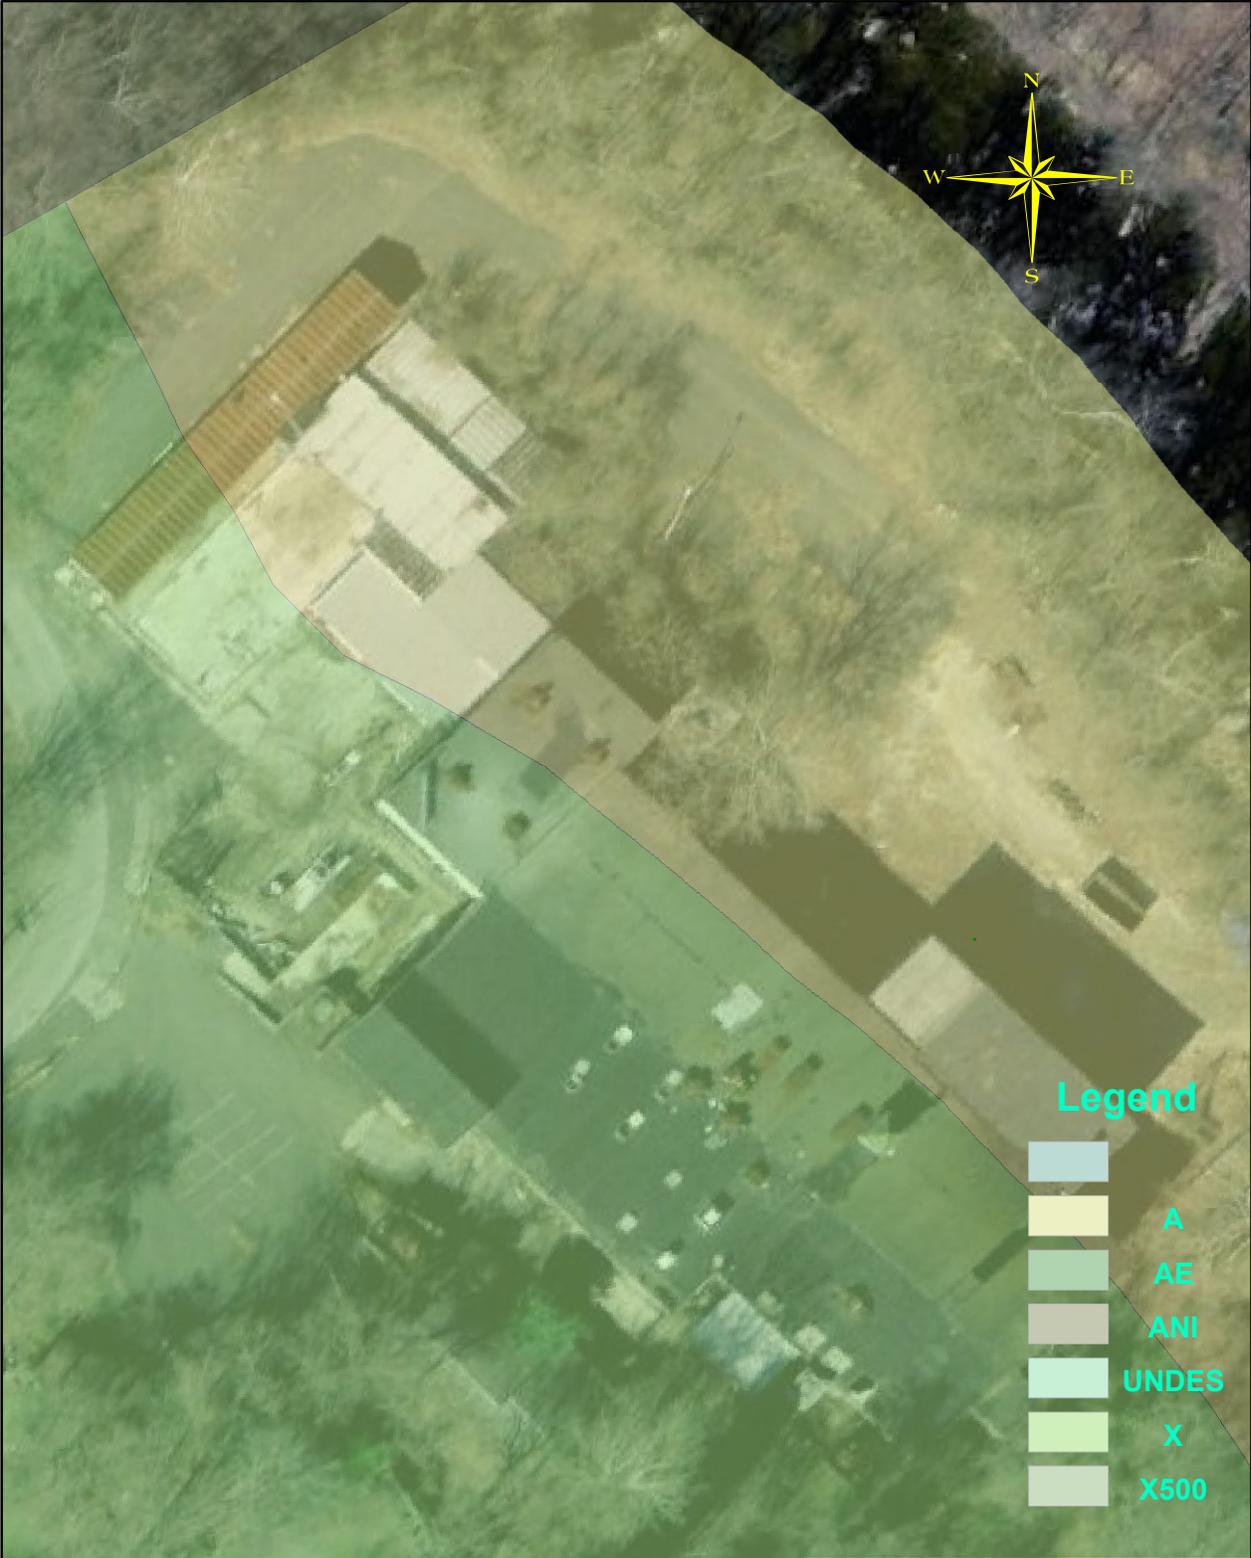
Date: 4/14/10	FIGURE 3 FLOODPLAIN MAP AXIL BELKO FACILITY KINGSVILLE, MD
Drawn By: GW	
Checked By: WTP

The facility is split between two distinct flood zone designations. As shown in **Figure 3**, the north eastern most portion of the property is located in the designated Zone A which is an area with a 1% chance of flooding and a 26 % chance of flooding over the life of a 30 year mortgage. Since detailed analyses are not typically performed in Zone A designations, the depths and base flood elevations are not known. The remainder of the property is designated as Zone X which is an area of minimal flood hazard. Historic flood records are unavailable at this time.

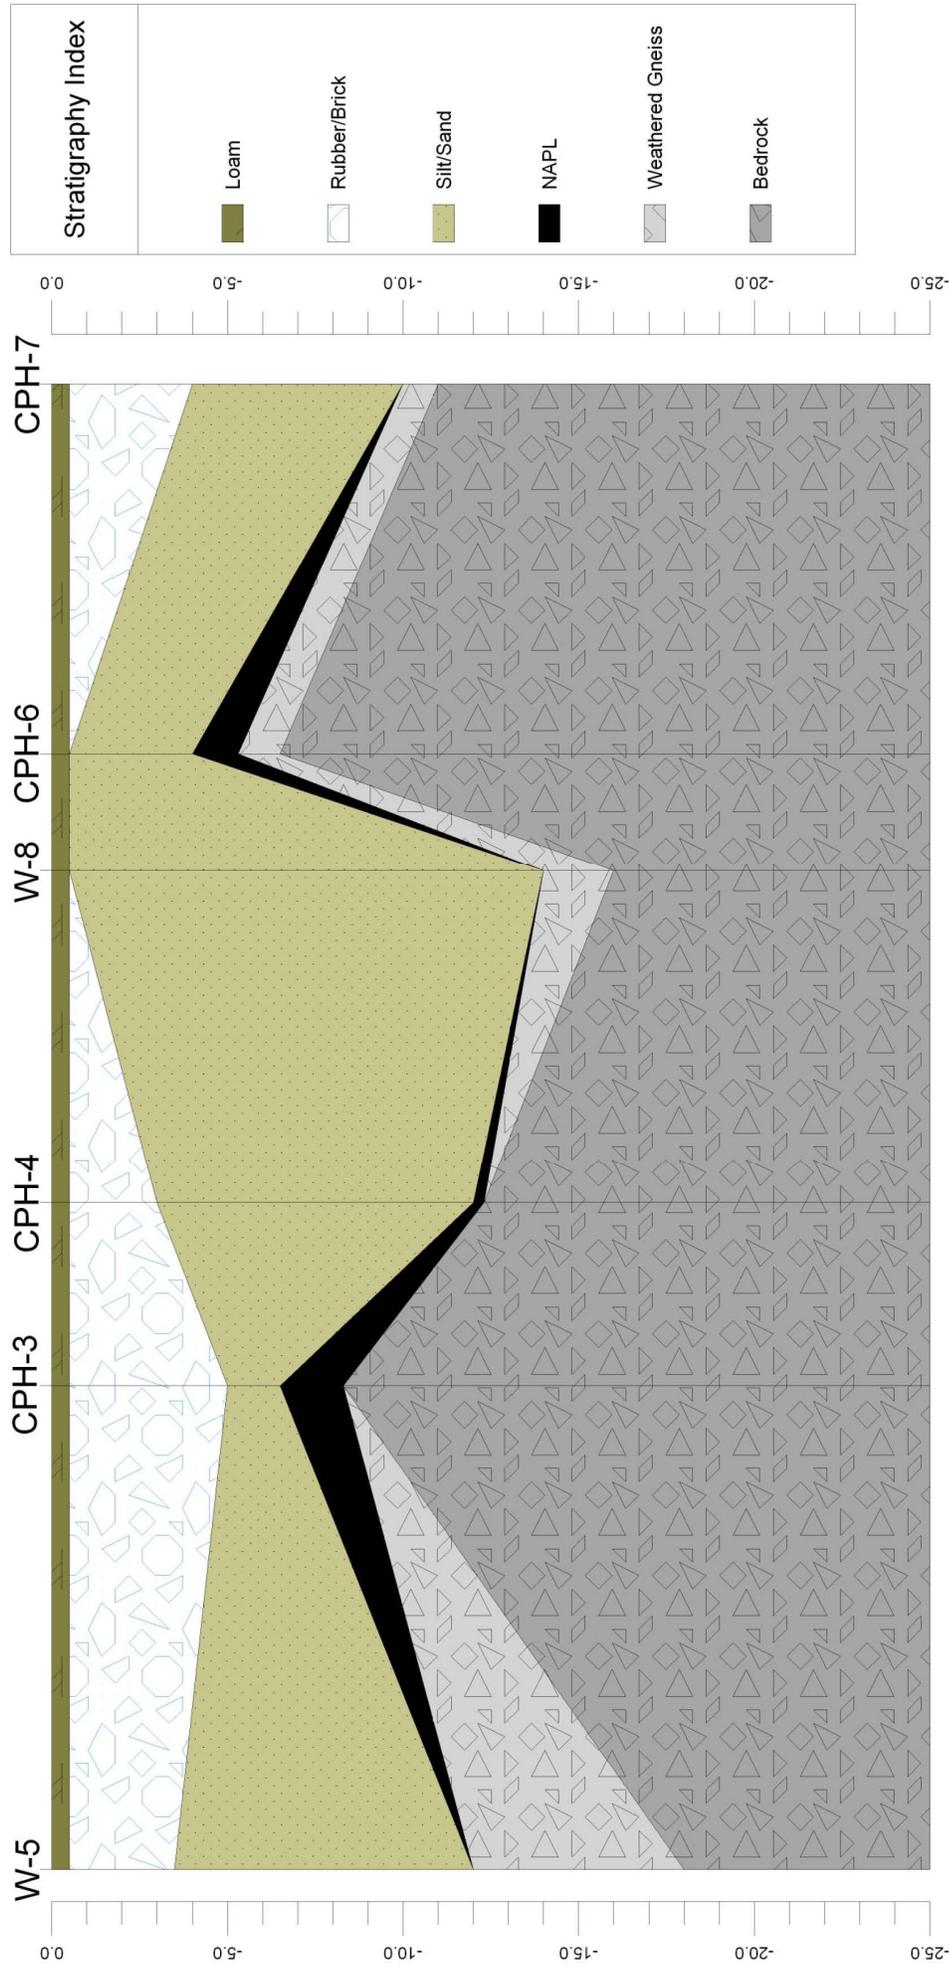
A S S O C I A T E S, I N C. 500 Coatesville Road Phone: (610) 869-3322 West Grove, PA 19390 Fax: (610) 869-9882	
		Date: 4/14/10	
FIGURE 6		CROSS SECTION MAP	
Drawn By: GW		AXIL BELKO FACILITY	
Checked By: WTF		KINGSVILLE, MD

LNAPL distribution in soil was evaluated based on soil boring logs and test pits performed by Langan and Tri-State and split spoon sampling performed by Brownfield during the installation of MW -5 through 9. **Figures 6-8** reveal, by way of cross section, the boring locations where residual or potentially free-phase LNAPL was detected in soils. Displayed as a black layer, the residual LNAPL was mapped based on well/pit log notations where severe staining or sheens were observed.

Residual and/or free phase LNAPL was observed anywhere between 2 and 15 feet below ground surface and spread out to as much as five feet in the soil column. Generally, LNAPL distribution follows the irregular bedrock layer beneath the site with the "source" areas appearing to be in the vicinity of MW-3 and MW-8. The potential for LNAPL to migrate is a function of the volume and occurrence of LNAPL (Free-phase) and the transport mechanism (water). It is not believed that LNAPL is migrating due to its own LNAPL head pressure considering that measurable quantities have not been recently observed.
