PHASE II INVESTIGATION REPORT

**AREA A: PARCEL A18
TRADEPOINT ATLANTIC
SPARROWS POINT, MARYLAND**

ARM Project No. 20010118

Revision 0 – November 12, 2020

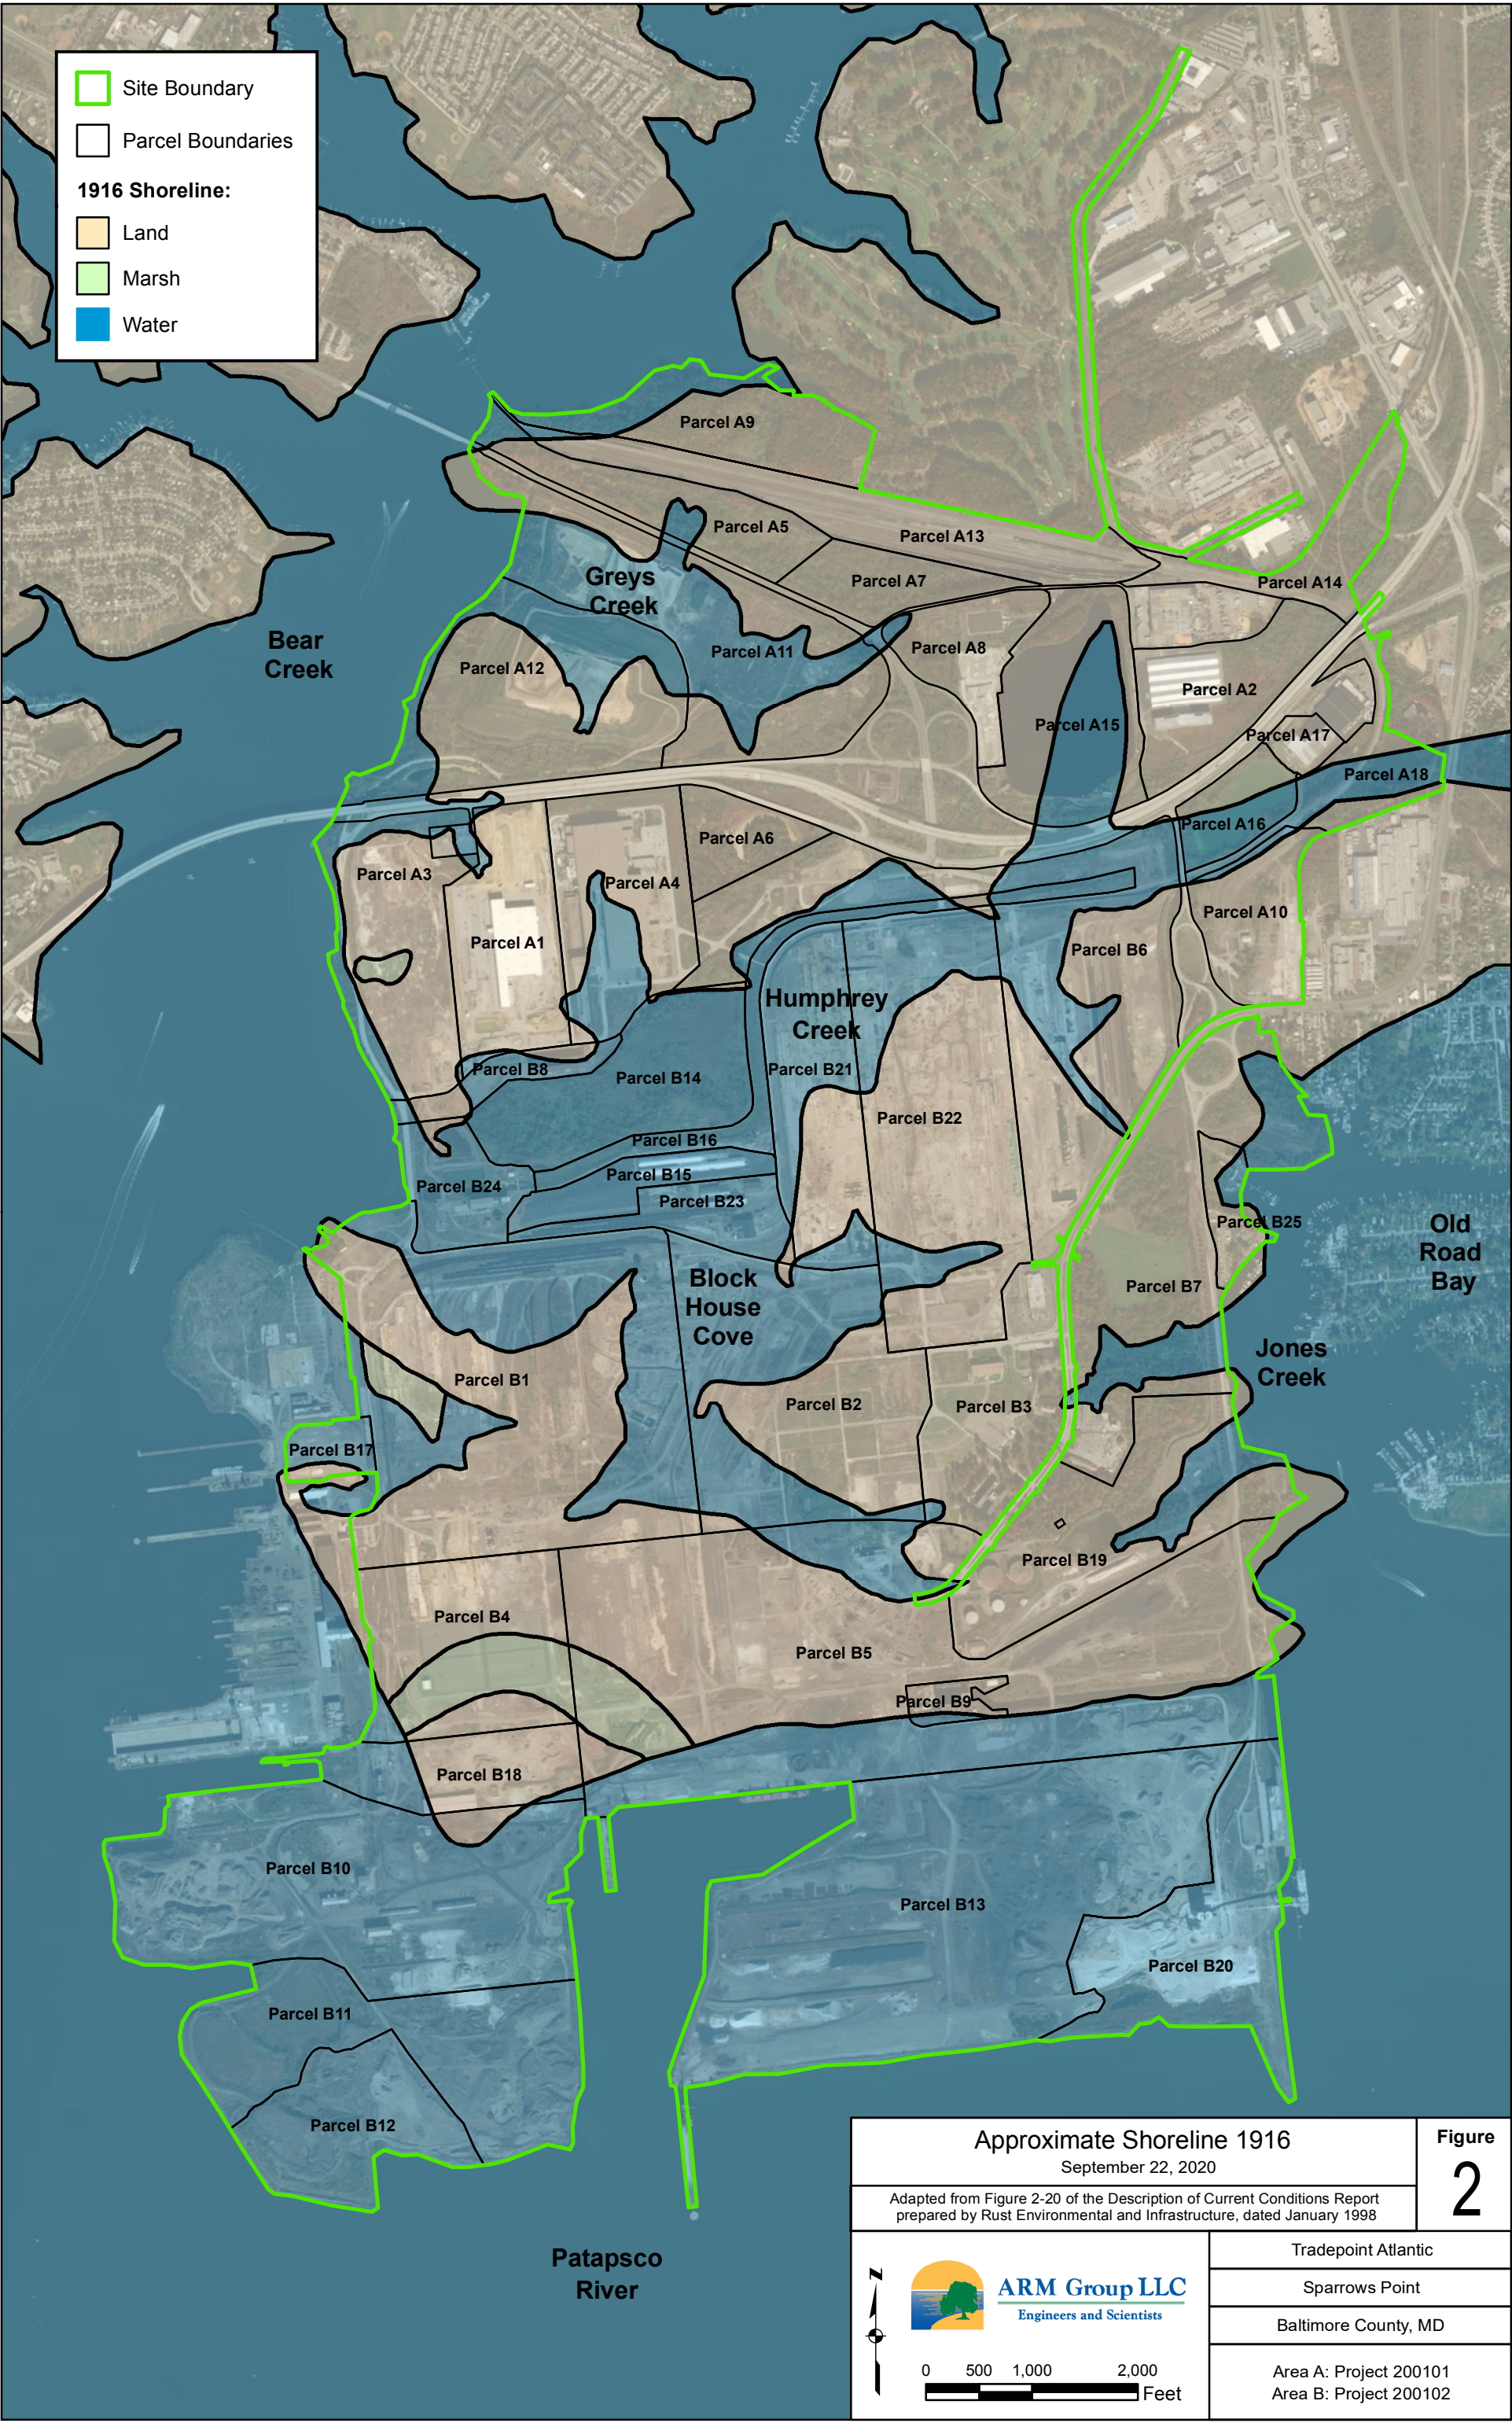
Groundcover at the Site is comprised of approximately 47% natural soils and 53% non-native fill materials (i.e., slag), based on the approximate shoreline of the Sparrows Point Peninsula in 1916, as shown on **Figure 2** (adapted from Figure 2-20 in the Description of Current Conditions (DCC) Report prepared by Rust Environment and Infrastructure dated January 1998).

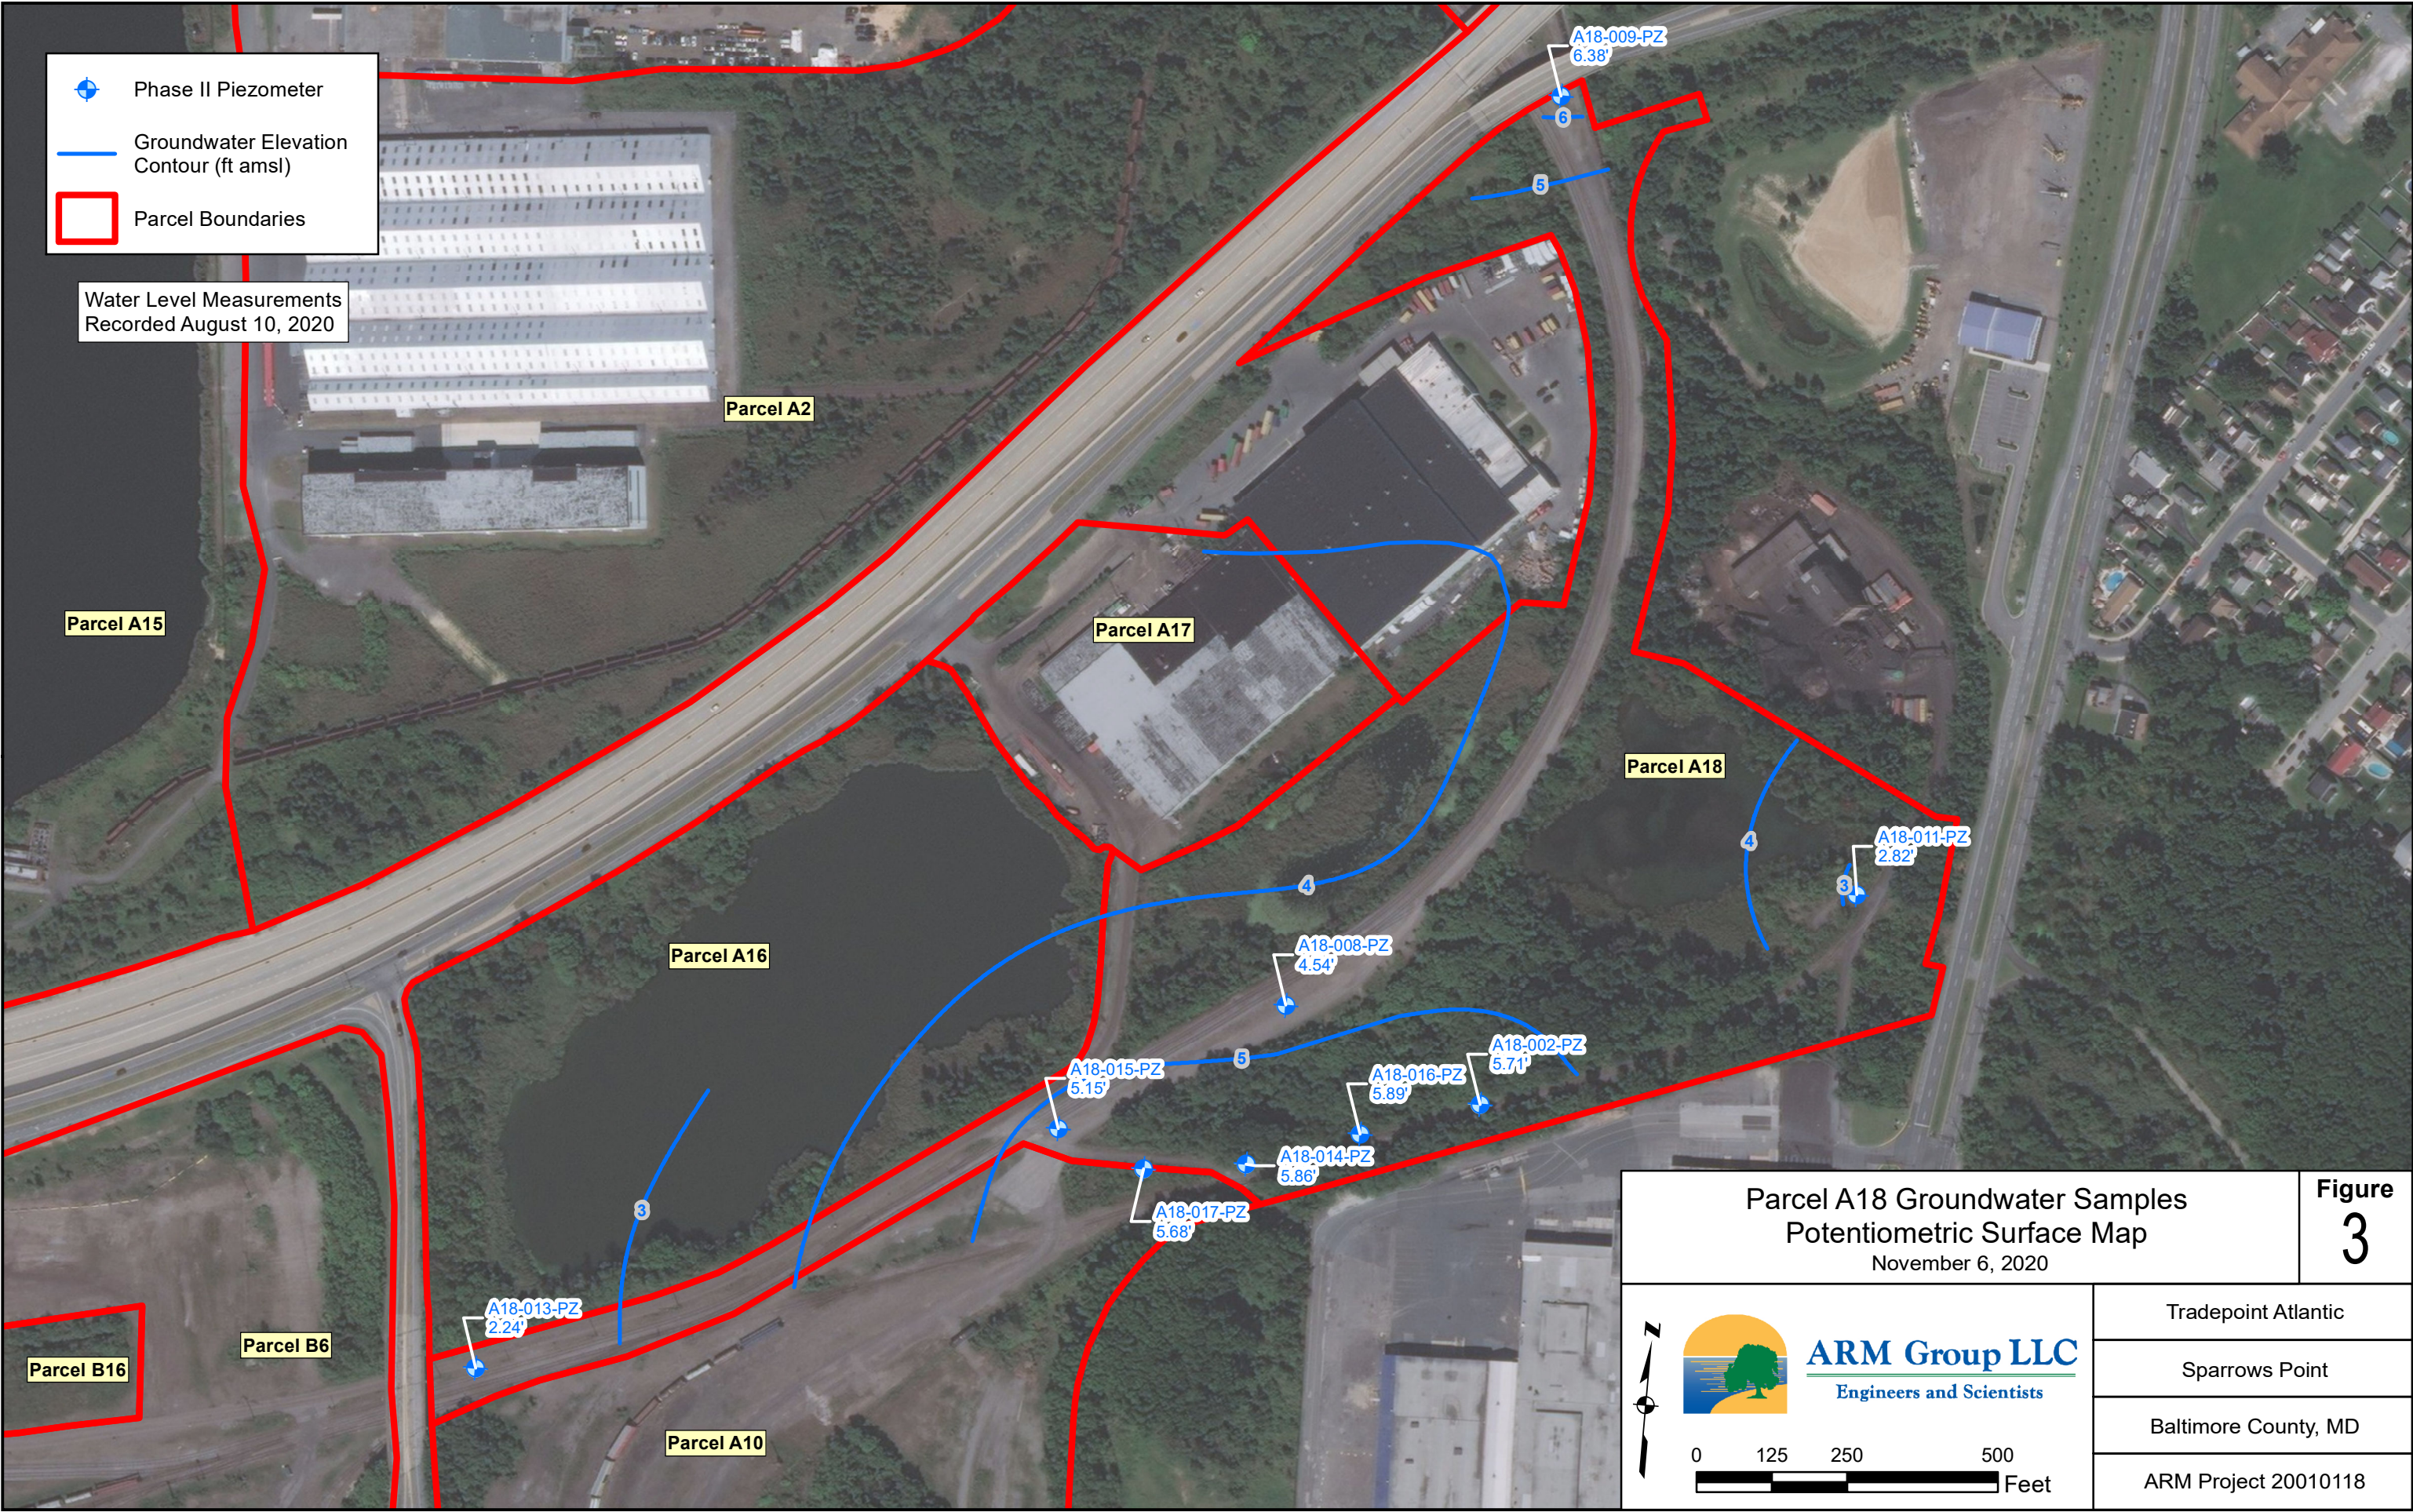
The piezometers were surveyed by a Maryland-licensed surveyor, and the supporting documentation from the survey is included in **Appendix C**. A synoptic round of groundwater level measurements was completed on August 10, 2020. Surveyed top of casing (TOC) and ground surface elevations for all applicable locations can be found in **Table 1**, along with the depth to water (DTW) measurements from this date. Based on the recorded field measurements, a groundwater potentiometric surface map was constructed for the shallow hydrogeologic zone. The localized potentiometric map for shallow groundwater has been included on **Figure 3**. The elevation contours suggest that groundwater flows generally in the direction of the on-site stormwater ponds and the larger pond located on the adjacent Parcel A16.

Nine shallow temporary groundwater piezometers (A18-002-PZ, A18-008-PZ, A18-009-PZ, A18-011-PZ, A18-013-PZ, A18-014-PZ, A18-015-PZ, A18-016-PZ, and A18-017-PZ) were included in the parcel-specific sampling plan to characterize groundwater and to support the definition of the groundwater potentiometric surface. A piezometer was originally specified to be installed at A18-005-SB; however, this location could not be installed due to equipment refusal and the presence of rail lines in the immediate vicinity which restricted further access. A18-008-PZ was installed as a replacement location. The locations where shallow groundwater samples were collected are provided on **Figure 3**.

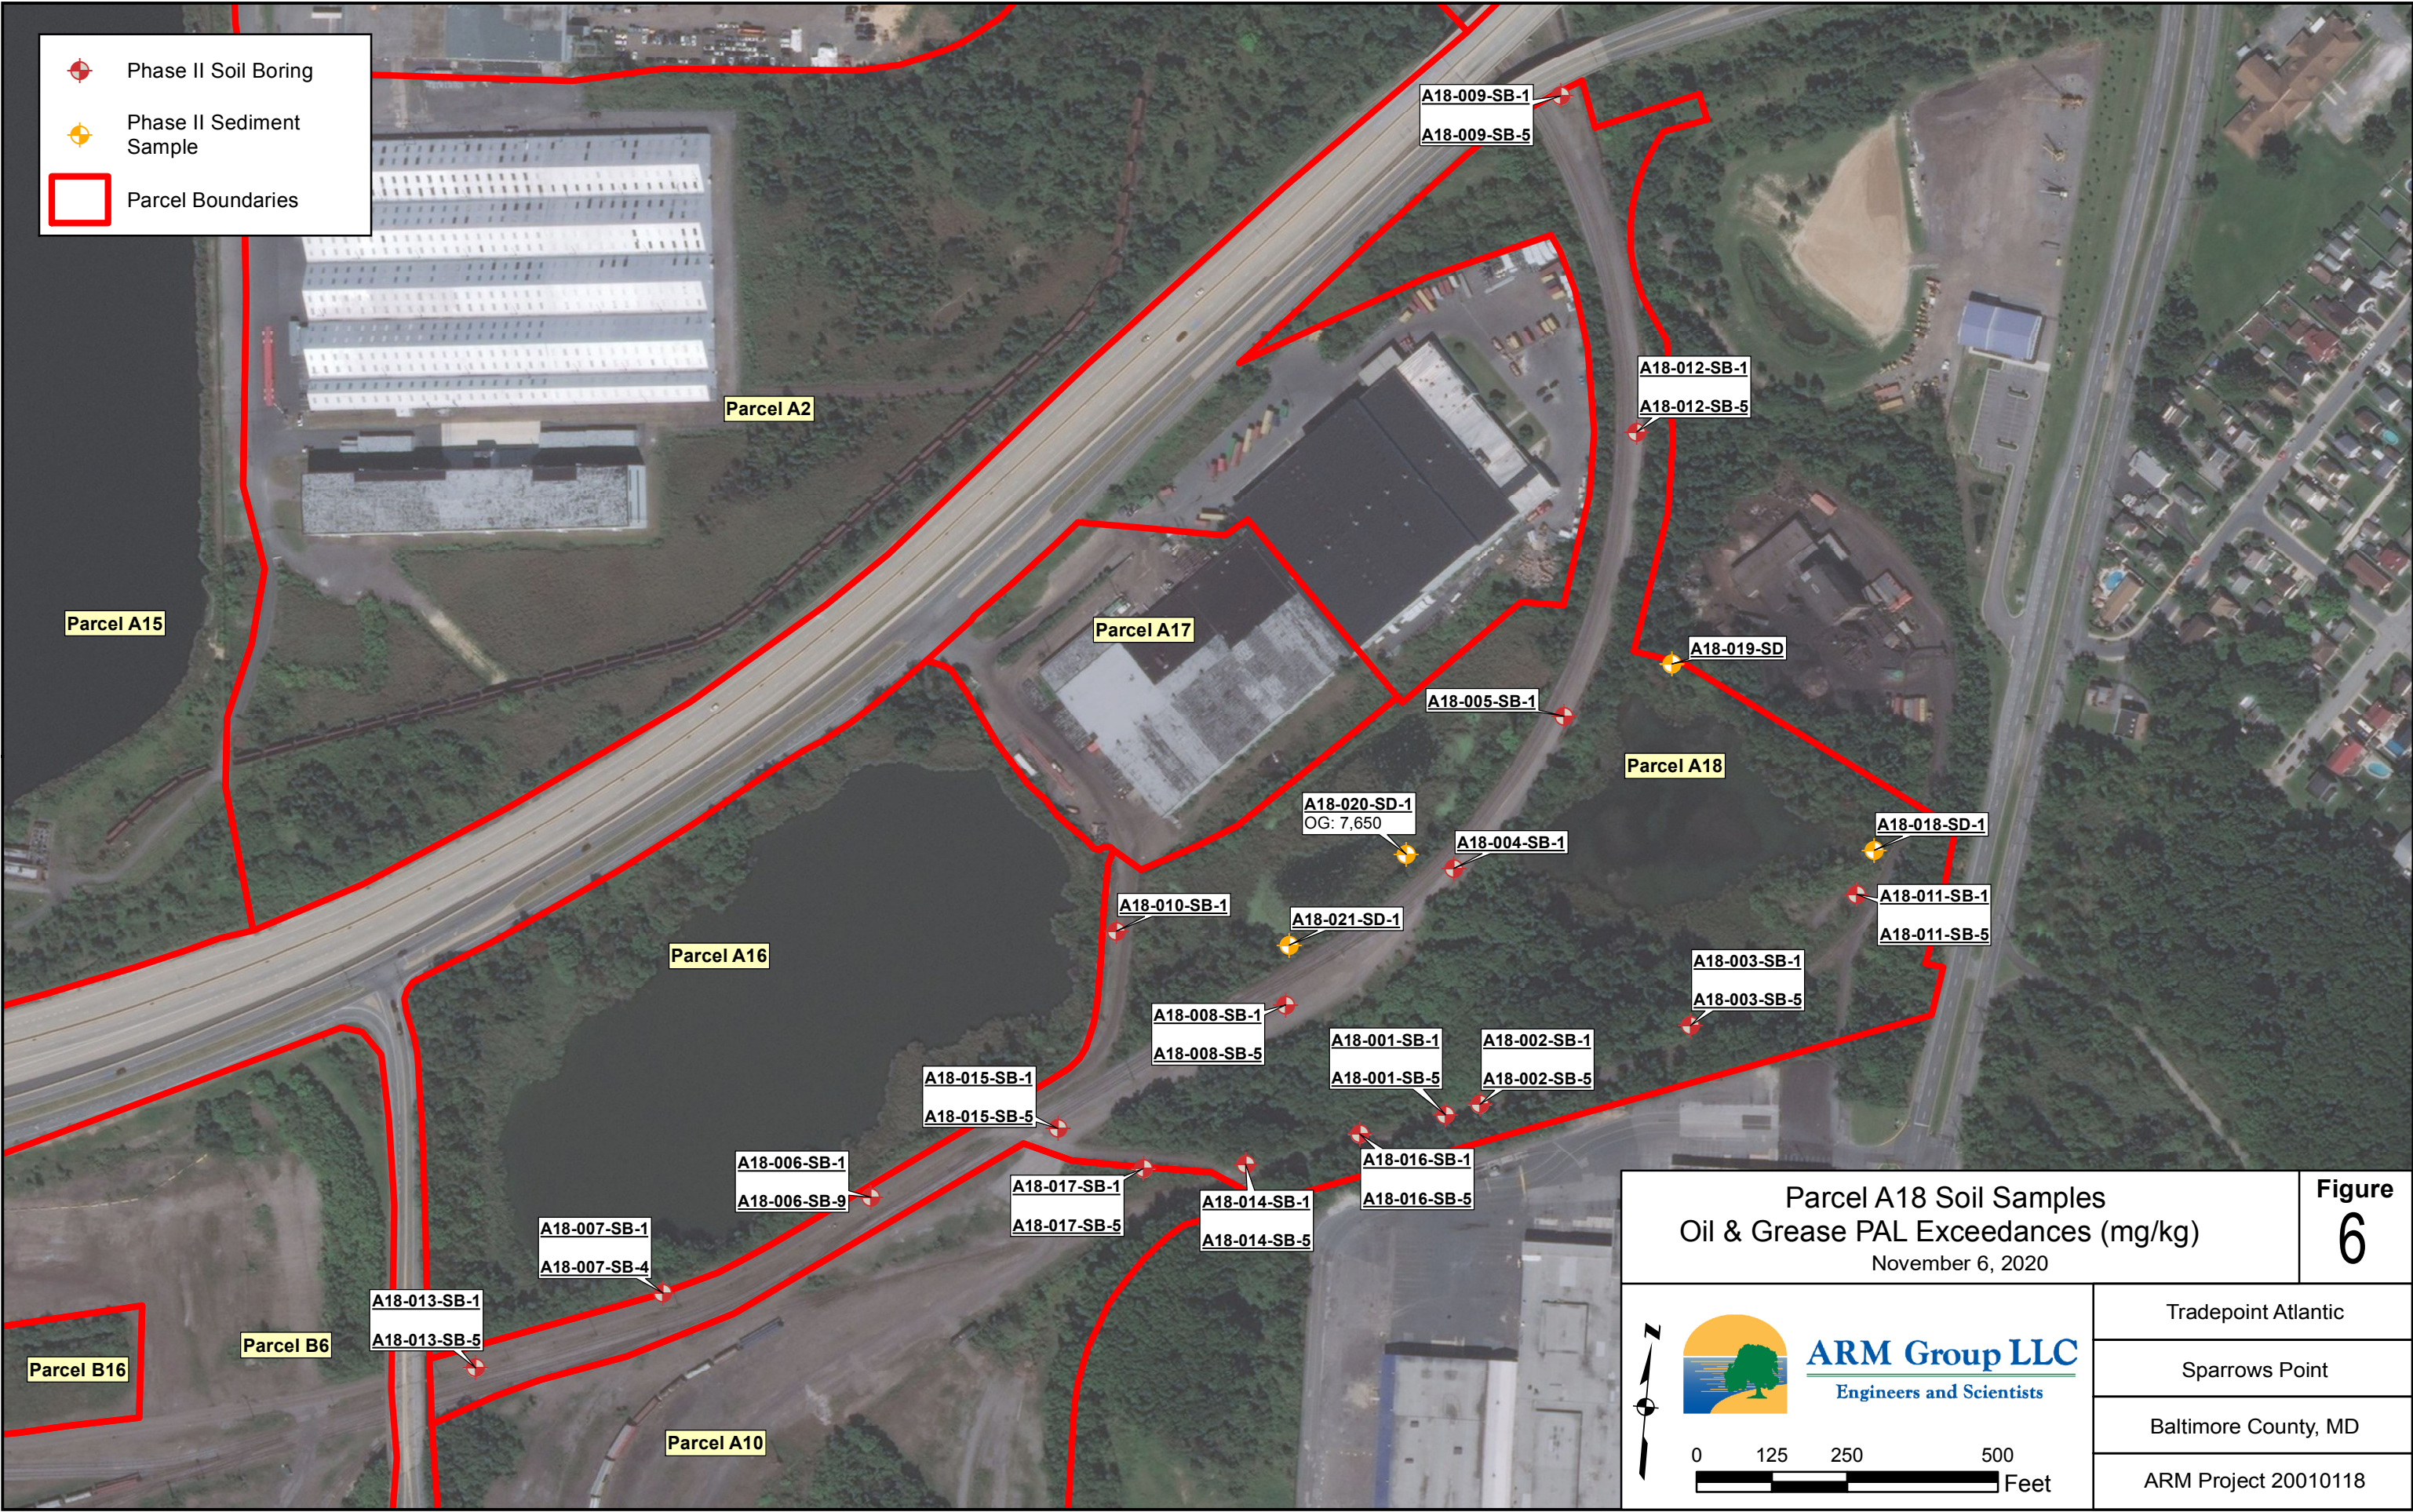
Figure
7

Table 7 provides a summary of inorganic constituents detected above the laboratory's MDLs in the soil samples collected from across the Site. Four inorganic constituents (arsenic, manganese, thallium, and vanadium) were detected above their respective PALs. Arsenic was detected above the PAL of 3 mg/kg in 23 soil samples analyzed for this constituent with a maximum detection of 18.1 mg/kg in A18-001-SB-10. Manganese was detected above the PAL of 26,000 mg/kg in seven soil samples with a maximum detection of 73,600 mg/kg in A18-006-SB-9. Thallium was detected above the PAL of 12 mg/kg in five soil samples with a maximum detection of 28.7 mg/kg in A18-009-SB-1. Vanadium was detected above the PAL of 5,800 mg/kg in three soil samples with a maximum detection of 11,300 mg/kg in A18-009-SB-1. The inorganic PAL exceedance locations and results have been provided on **Figure 7**.

Table 6 and **Table 7** provide summaries of the detected organic compounds and inorganics in the soil samples submitted for laboratory analysis, while **Figure 5** through **Figure 7** present the soil sample results that exceeded the PALs. PAL exceedances in soil within Parcel A18 were limited to benzo[a]pyrene (two samples), Oil & Grease (one sample), arsenic (23 samples), manganese (seven samples), thallium (five samples), and vanadium (three samples). **Table 8** provides a summary of results for all PAL exceedances in soil, including maximum values and detection frequencies. VOCs, PCBs, and TPH-DRO/GRO were not detected above their respective PALs and are not considered to be significant soil contaminants in Parcel A18.

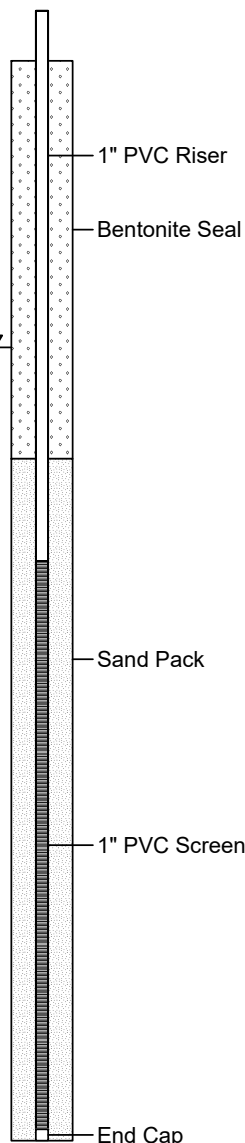
Boring terminated at 19' bgs due to water and piezometer installation
TOC: Top of PVC casing
DTW: Depth to water
bgs: Below ground surface

Riser Stickup: 3.04' ags
Riser: 0 - 9' bgs
Screen: 9 - 19' bgs [Slot Size: 0.010"]
Sand Pack: 7 - 19' bgs [Grain Size: WG #2]
Bentonite Seal: 0 - 7' bgs [Grain Size: bentonite chips]

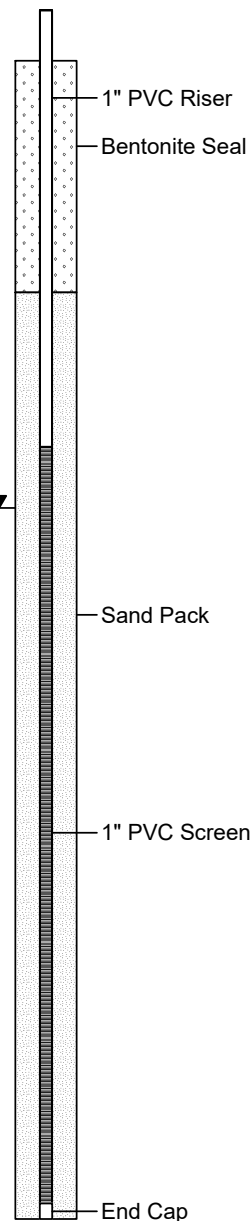
Boring terminated at 15' bgs due to water and piezometer installation
TOC: Top of PVC casing
DTW: Depth to water
bgs: Below ground surface

Riser Stickup: 2.81' ags
Riser: 0 - 5' bgs
Screen: 5 - 15' bgs [Slot Size: 0.010"]
Sand Pack: 3 - 15' bgs [Grain Size: WG #2]
Bentonite Seal: 0 - 3' bgs [Grain Size: bentonite chips]

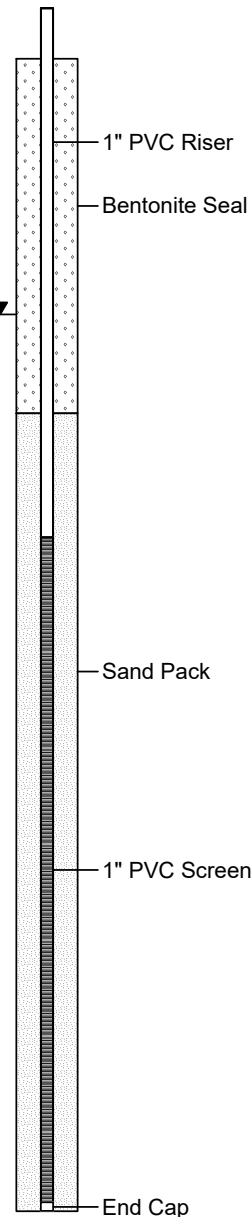
Boring terminated at 26' bgs due to water and piezometer installation
TOC: Top of PVC casing
DTW: Depth to water
bgs: Below ground surface

Riser Stickup: 2.99' ags
Riser: 0 - 11' bgs
Screen: 11 - 26' bgs [Slot Size: 0.010"]
Sand Pack: 9 - 26' bgs [Grain Size: WG #2]
Bentonite Seal: 0 - 9' bgs [Grain Size: bentonite chips]
