Re: **CAP Addendum and Work Plan Modification**  
**Sheetz Store #177**  
**3281 Main Street**  
**Manchester, Maryland**  
**MDE Case # 06-0056CL**  
**MDE Facility ID No. 6297**

Geotechnical Field Infiltration Study  
Sheetz Property  
Carroll County, Maryland  
FTG Job No. F10027

Re: Geotechnical Field Infiltration Study  
**Sheetz Property**  
3281 Main St.  
Manchester, Maryland 21102  
FTG Job No.: F10027

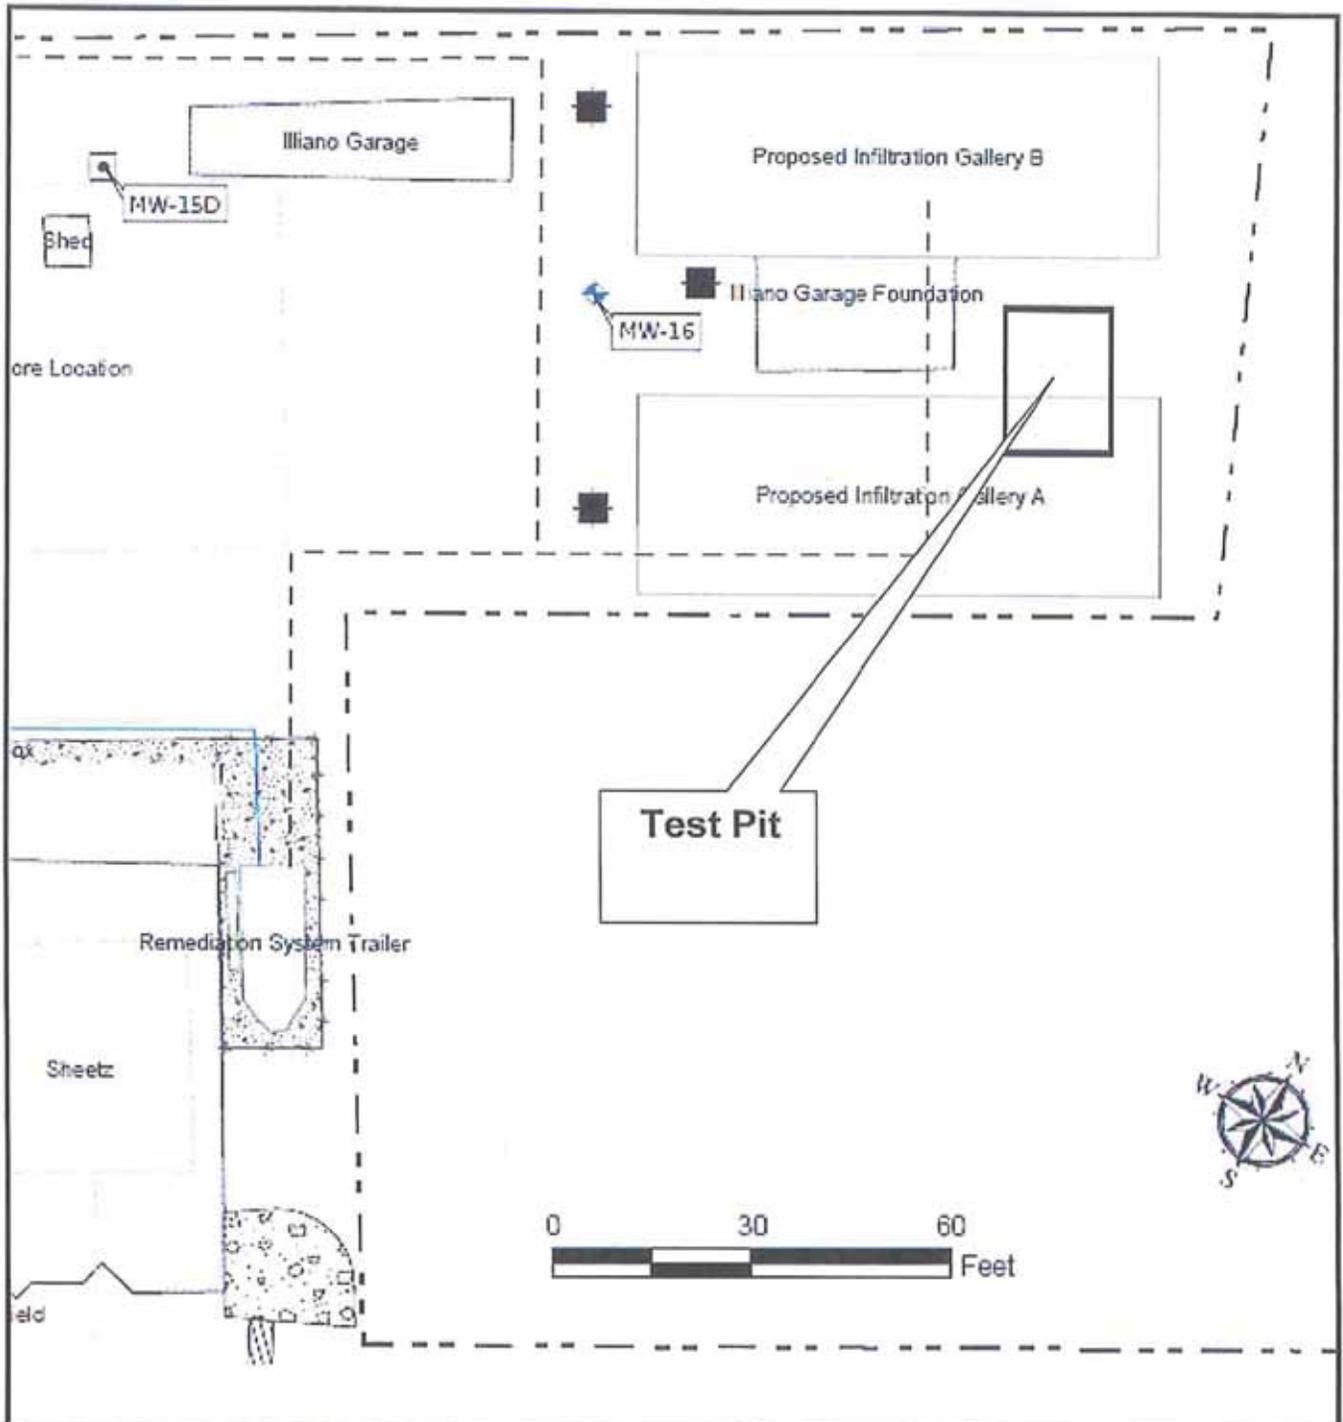
Figure No. : 3

## Test Location Plan

Based on the information provided by the client, we understand that proposed for development at the site is an infiltration structure capable of processing a peak demand of 20,000 gallons per day. The proposed facility is to be generally located on the site as shown on the Test Location Plan (Figure 3) in the Appendix.

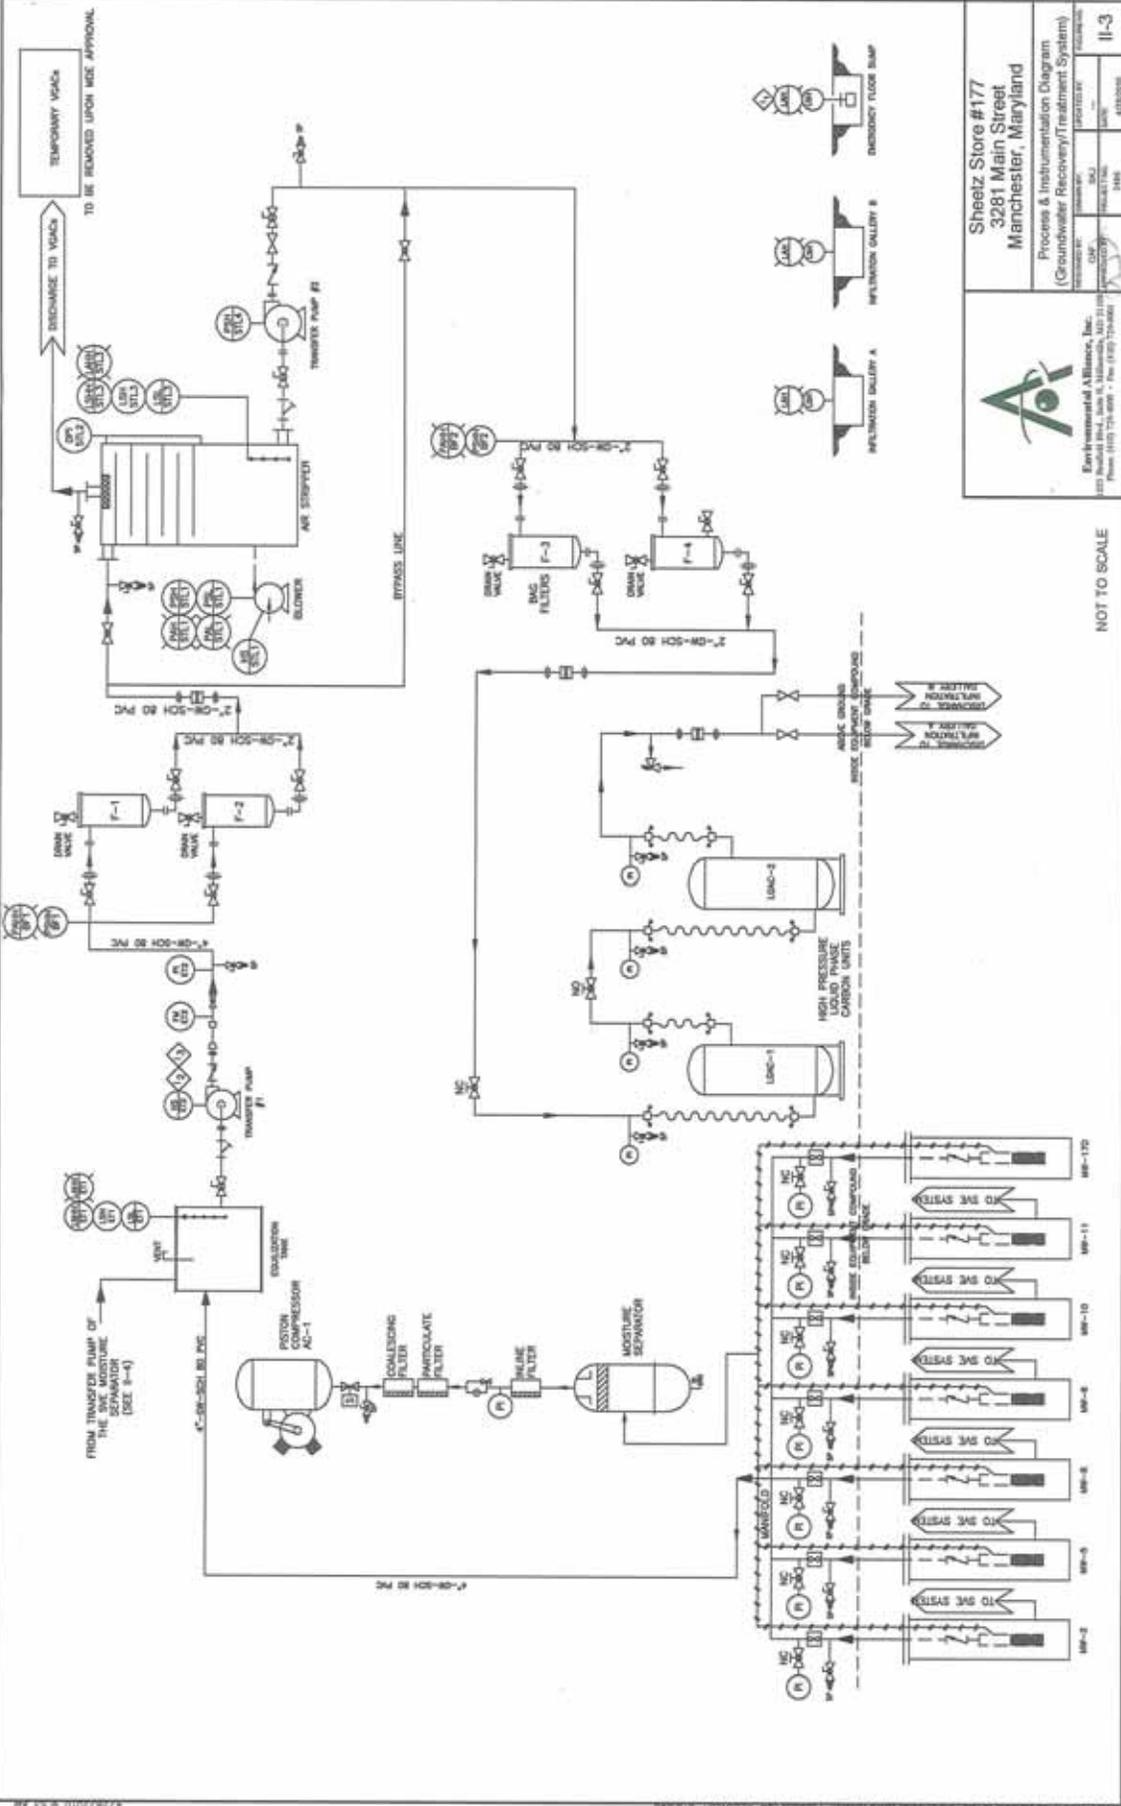
Process & Instrumentation Diagram  
 (Groundwater Recovery/Treatment System)

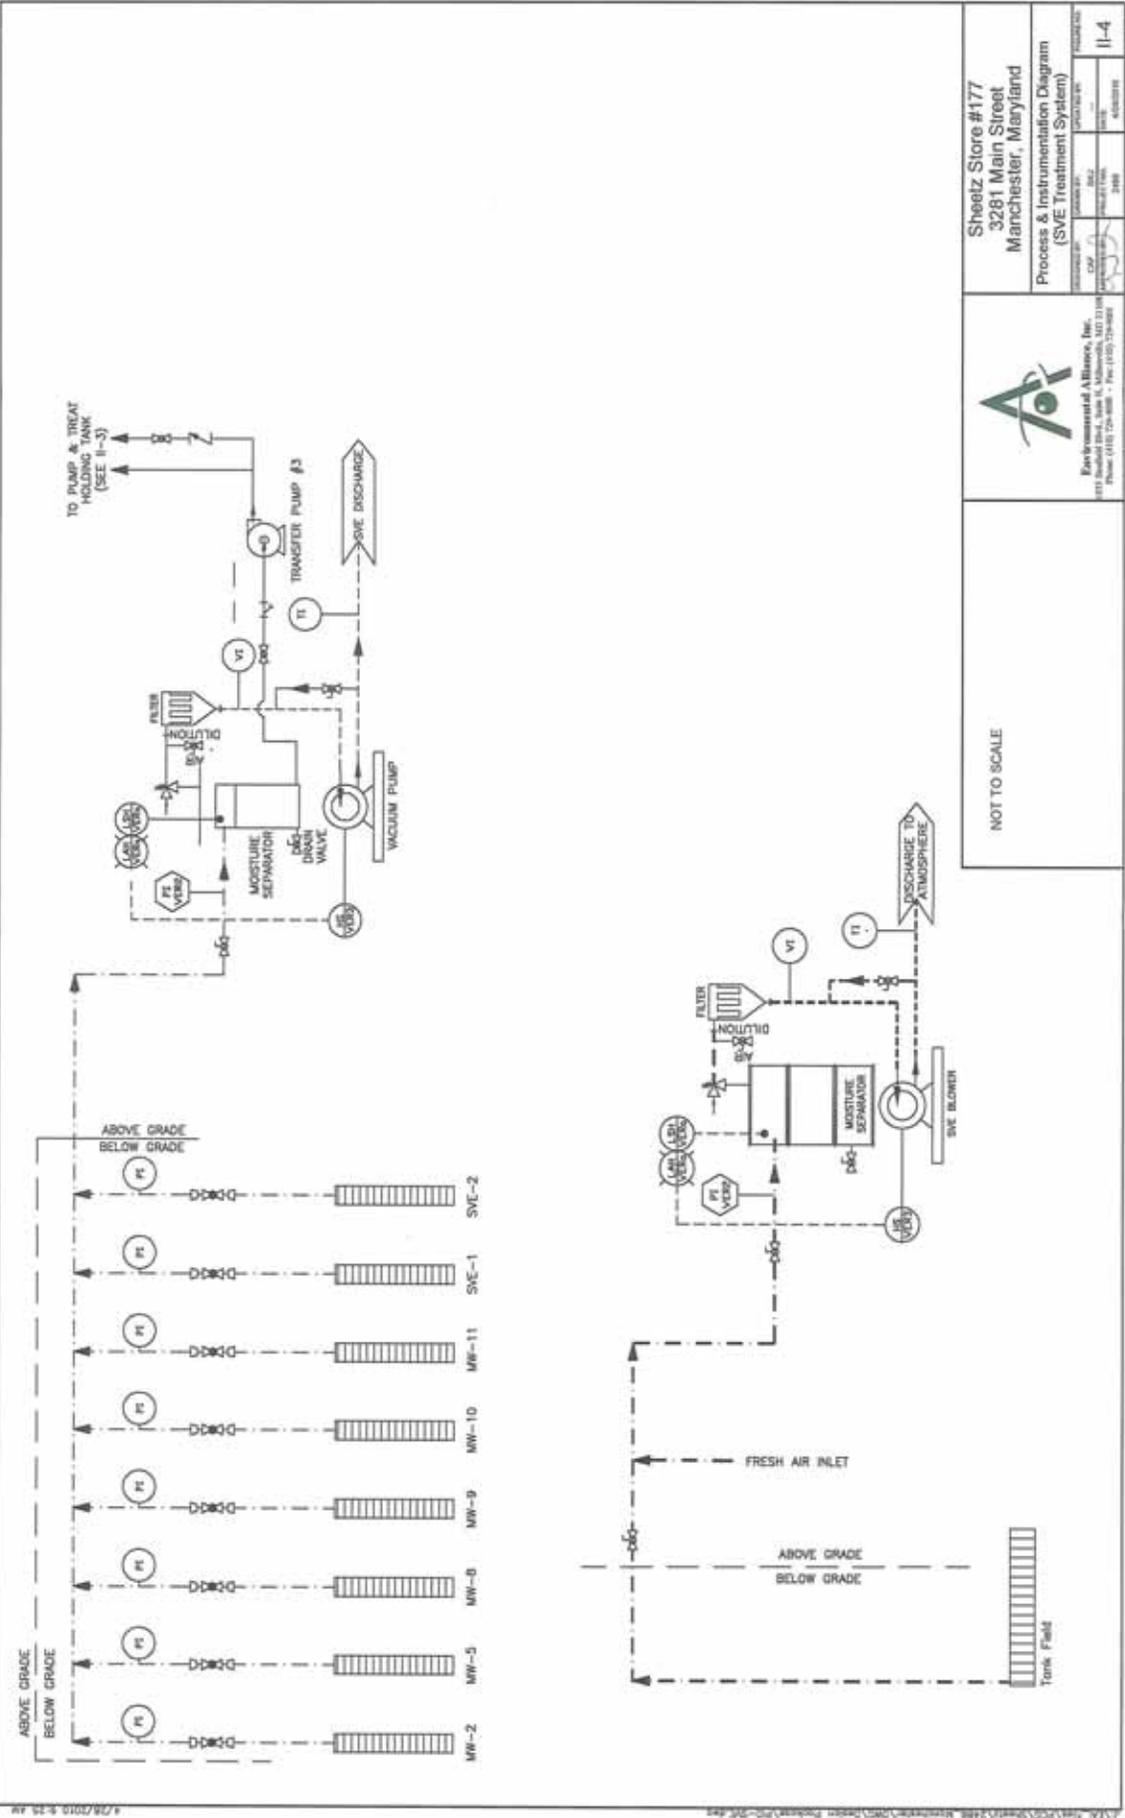
Sheet Store #177  
 3281 Main Street  
 Manchester, Maryland  
 Process & Instrumentation Diagram  
 (SVE Treatment System)

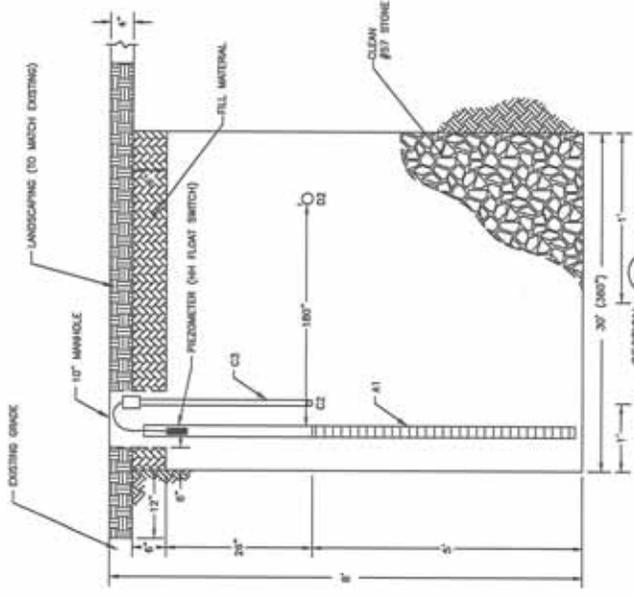
SECTION E 2/5  
TYPICAL CHARACTERISTIC OF INFILTRATION GALLERY

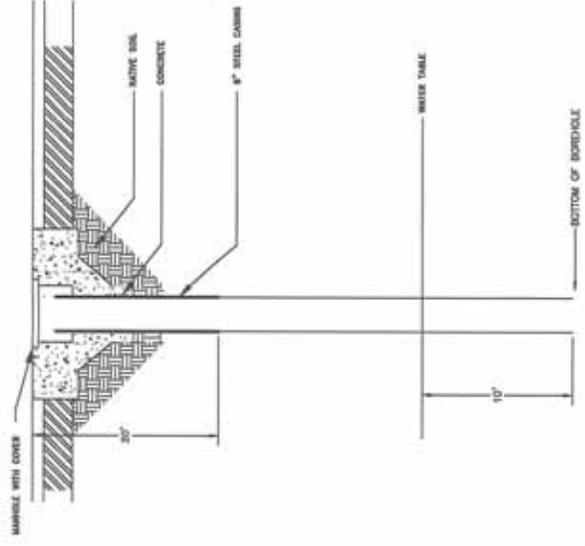
TOOL DEPTH = 10' INTO ORIGINAL GROUNDWATER TABLE  
OPEN BOREHOLE = 20" TO TO  
NUMBER OF POINTS = THREE  
WELL HEAD = 10" MANHOLE  
WELL COVER = 6" OPEN BOREHOLE

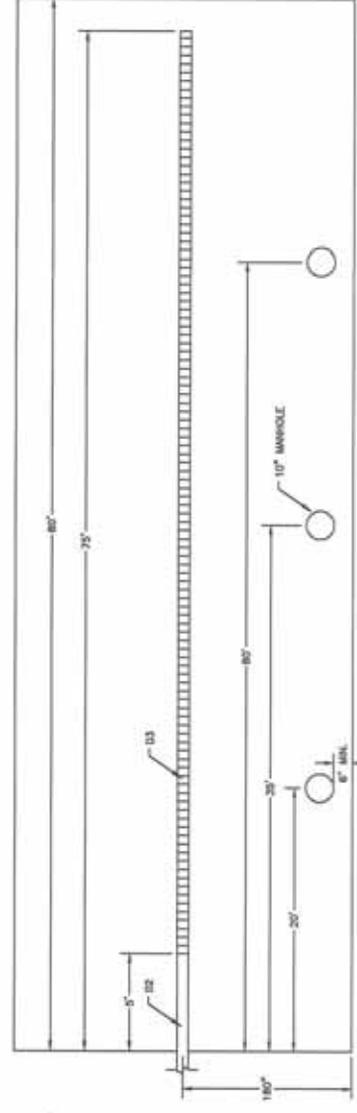
TYPICAL INFILTRATION GALLERY CROSS SECTION

Sheetz Store #177  
2381 Main Street  
Manchester, Maryland  
Infiltration Gallery Cross Section  
and Monitoring Point Details
