Road and Utility Investigation Report (B22)

Developed in Support of Construction Activities for Area B: Parcel B22, Phase 1

Tradepoint Atlantic Sparrows Point, Maryland

Revision 0 December 16, 2016

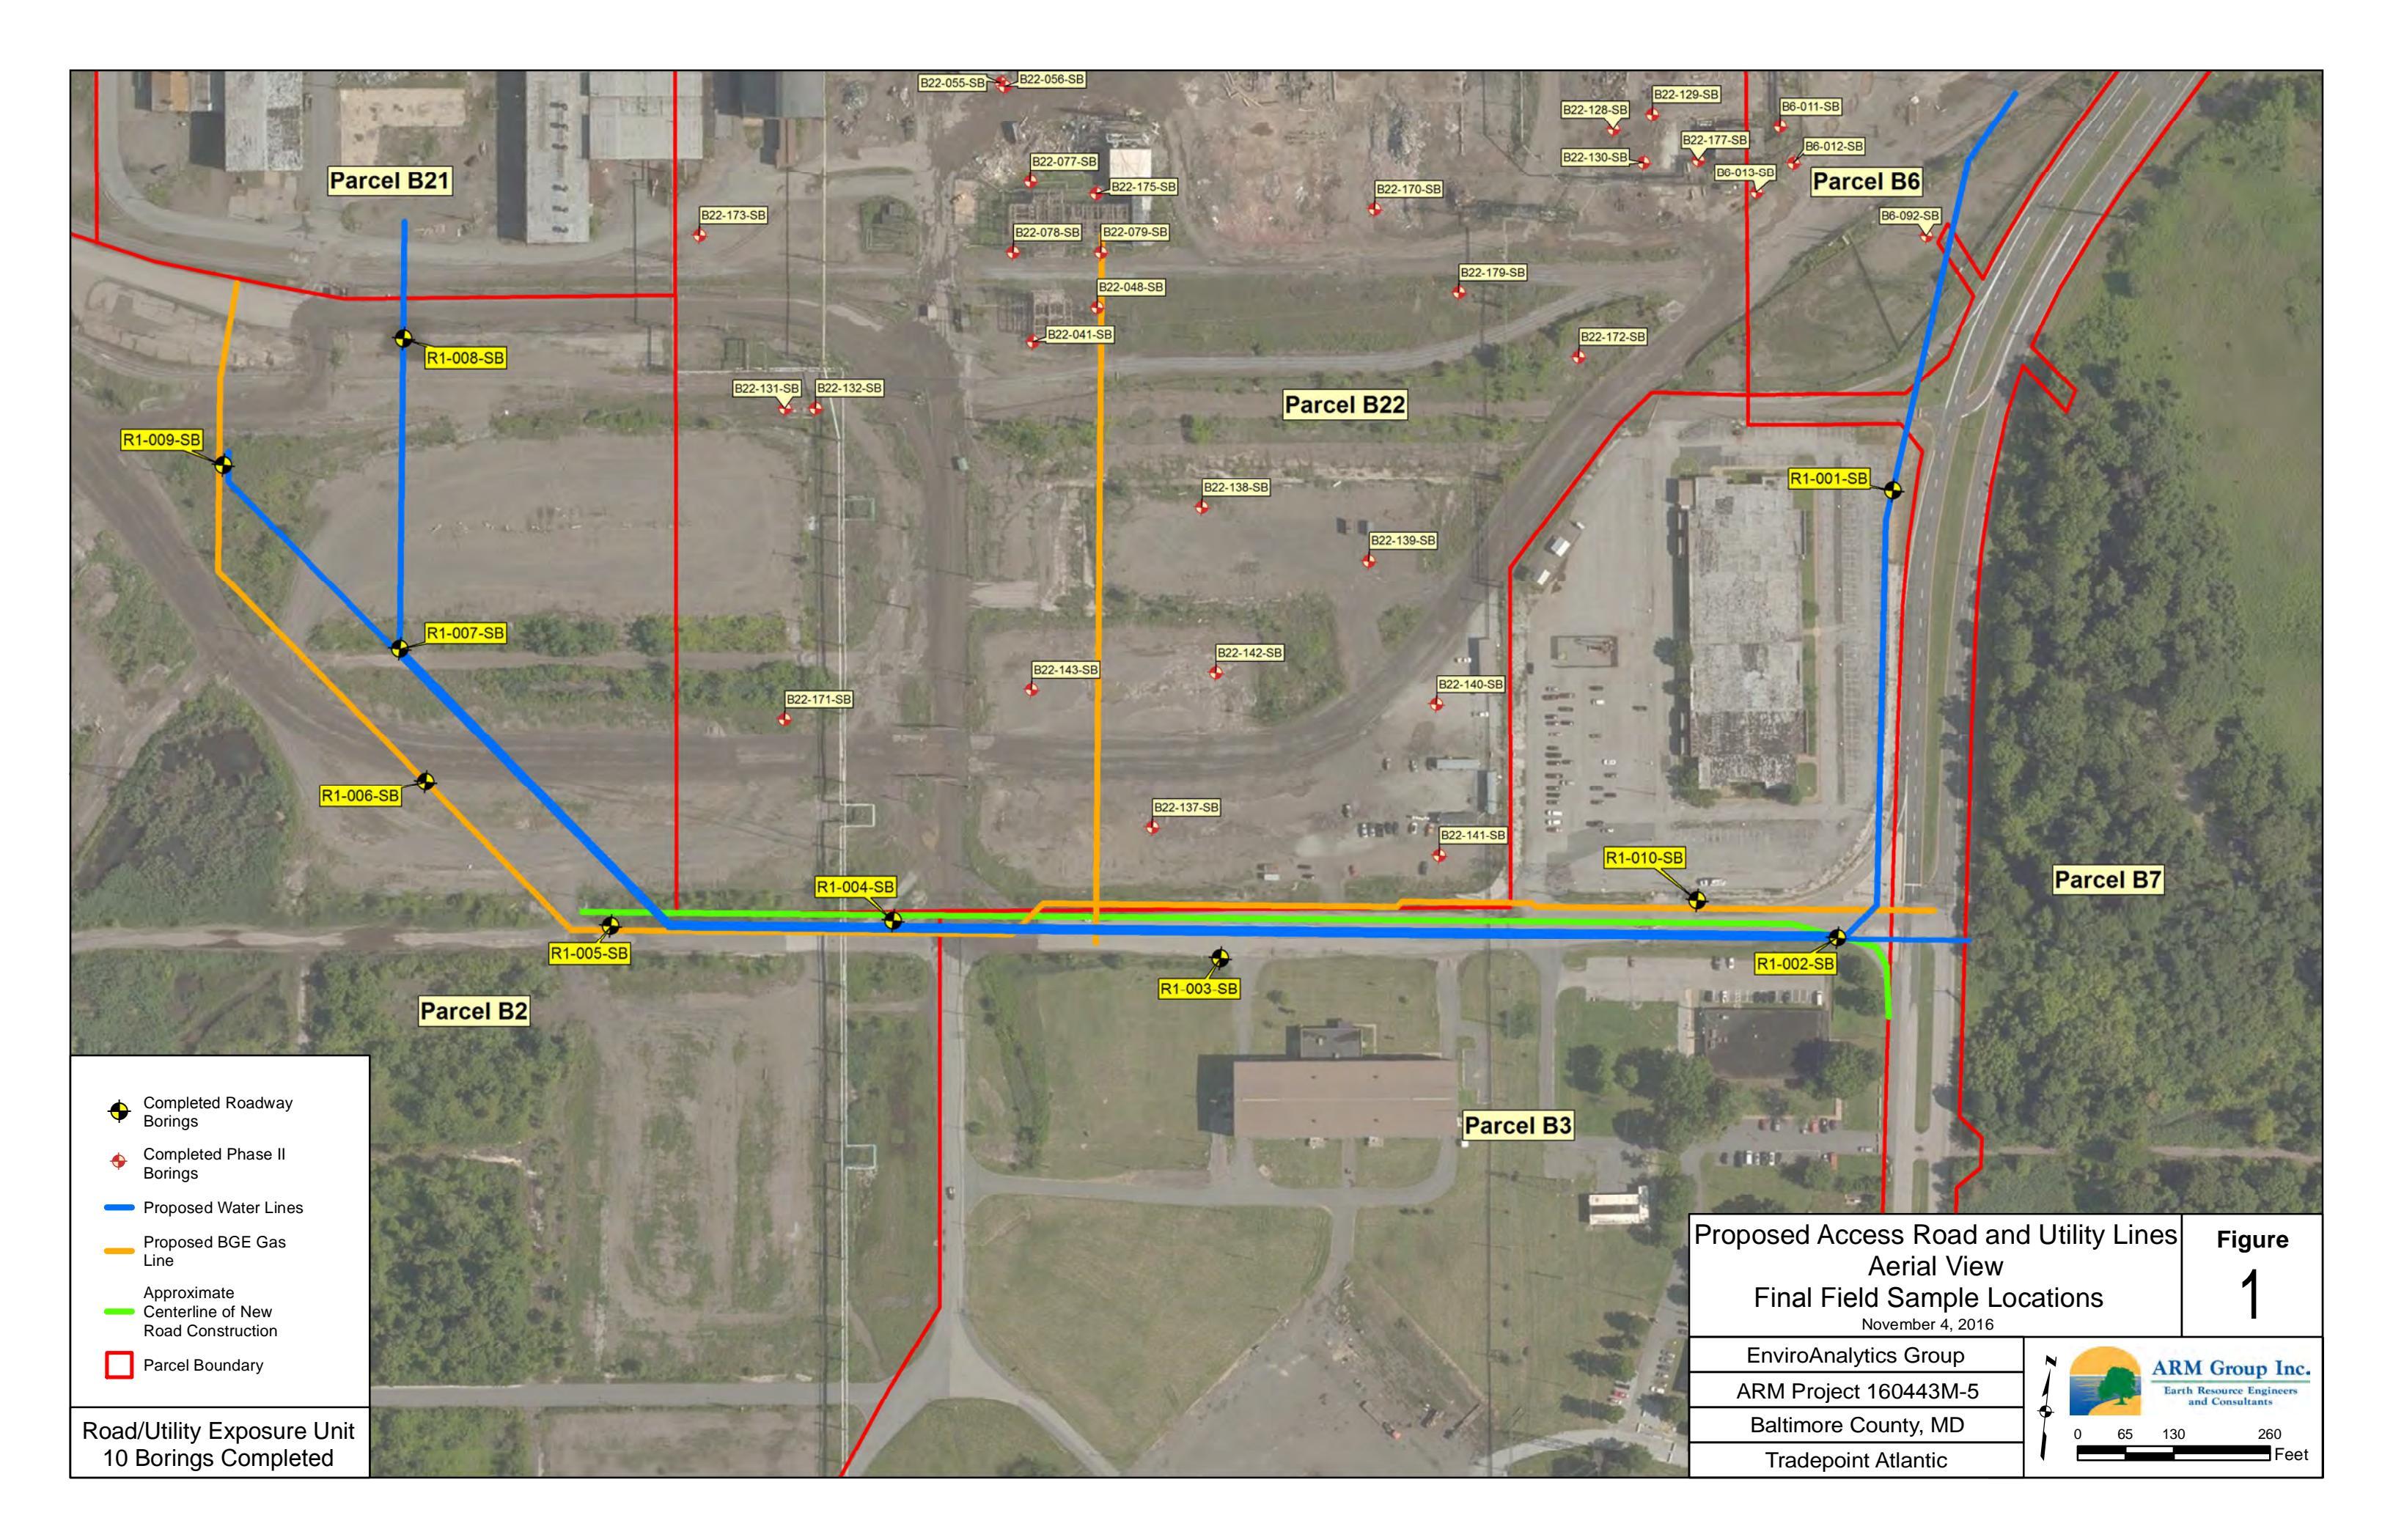
The locations of the proposed utilities and roadway alignment are provided on **Figure 1**, along with the locations of the completed borings and corresponding identification numbers. This figure shows an aerial image of the area toward the south end of Parcel B22 which was investigated.

Soil samples were collected from the locations identified on **Figure 1** in accordance with procedures referenced in the QAPP Worksheet 21 - Field SOPs (Standard Operating Procedures), SOP No. 009 – Sub-Surface Soil Sampling. Regarding soil sampling depth, a shallow sample was collected from the 0 to 1 foot depth interval, and a deeper sample was collected from the 4 to 5 foot depth interval. Each boring provided two analytical soil samples, yielding a total of 20 samples for this investigation. It should be noted that no soil samples were collected from a depth that is below the water table. If asphalt and/or roadway sub-base occupied the 0 to 1 foot below ground surface (bgs) sample, the interval was shifted to the depth of the first observed underlying soil interval. In the event of refusal prior to collecting the 5 foot sample, the deeper sample was collected from the lowest possible interval (at least 4.5 feet bgs in each case). Borings were completed as close as possible to the proposed locations using a handheld GPS unit as guidance.
